November, 2005

SR-68, 2600 South to I-15 in Davis County SR-68 **Project No. SP-STP-0068(21)68E** 2600 South

#### Introduction

This technical memorandum documents the existing infrastructure conditions, evaluation of geometric elements, and accident information for

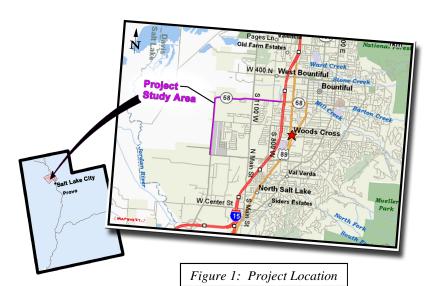
the SR-68/500 South corridor. from the intersection of 2600 South and Redwood Road to the southbound ramps west of I-15, in West Bountiful and Woods Cross. Utah. Refer to the project location in Figure 1. This section of SR-68 is considered an
